A Sediment Study of Little Leading Creek

Guy Riefler¹, Ben Stuart¹, Tiao Chang¹,
Barbara Flowers², Jennifer Chapman-
Kleski³, Yanhui Fang¹

Little Leading Creek

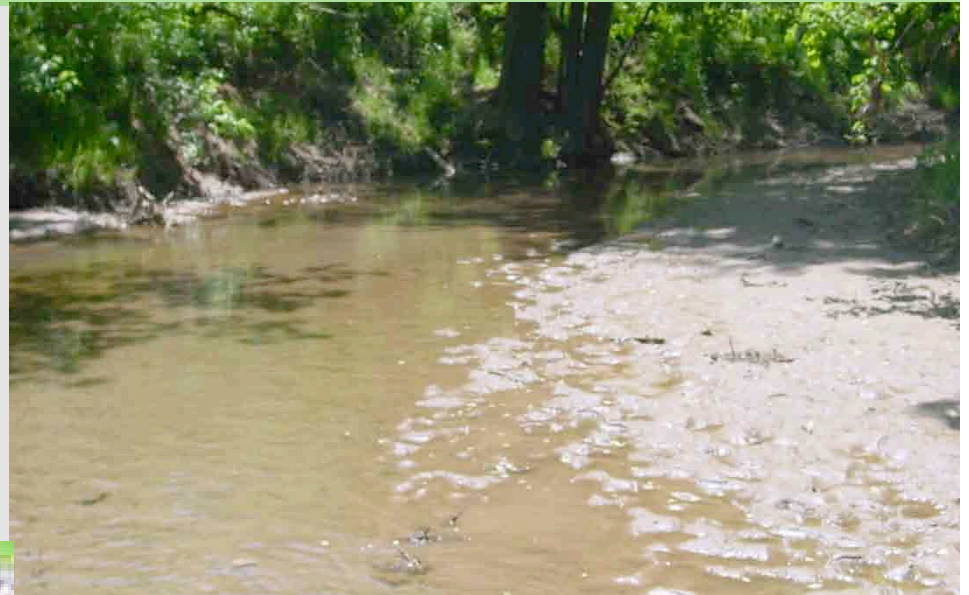
Impairment of Creek

- fails to meet warm water habitat criteria because of excessive sand
- filled pools results in poor breeding and few hiding places
- fish assemblages diverse but of very small size

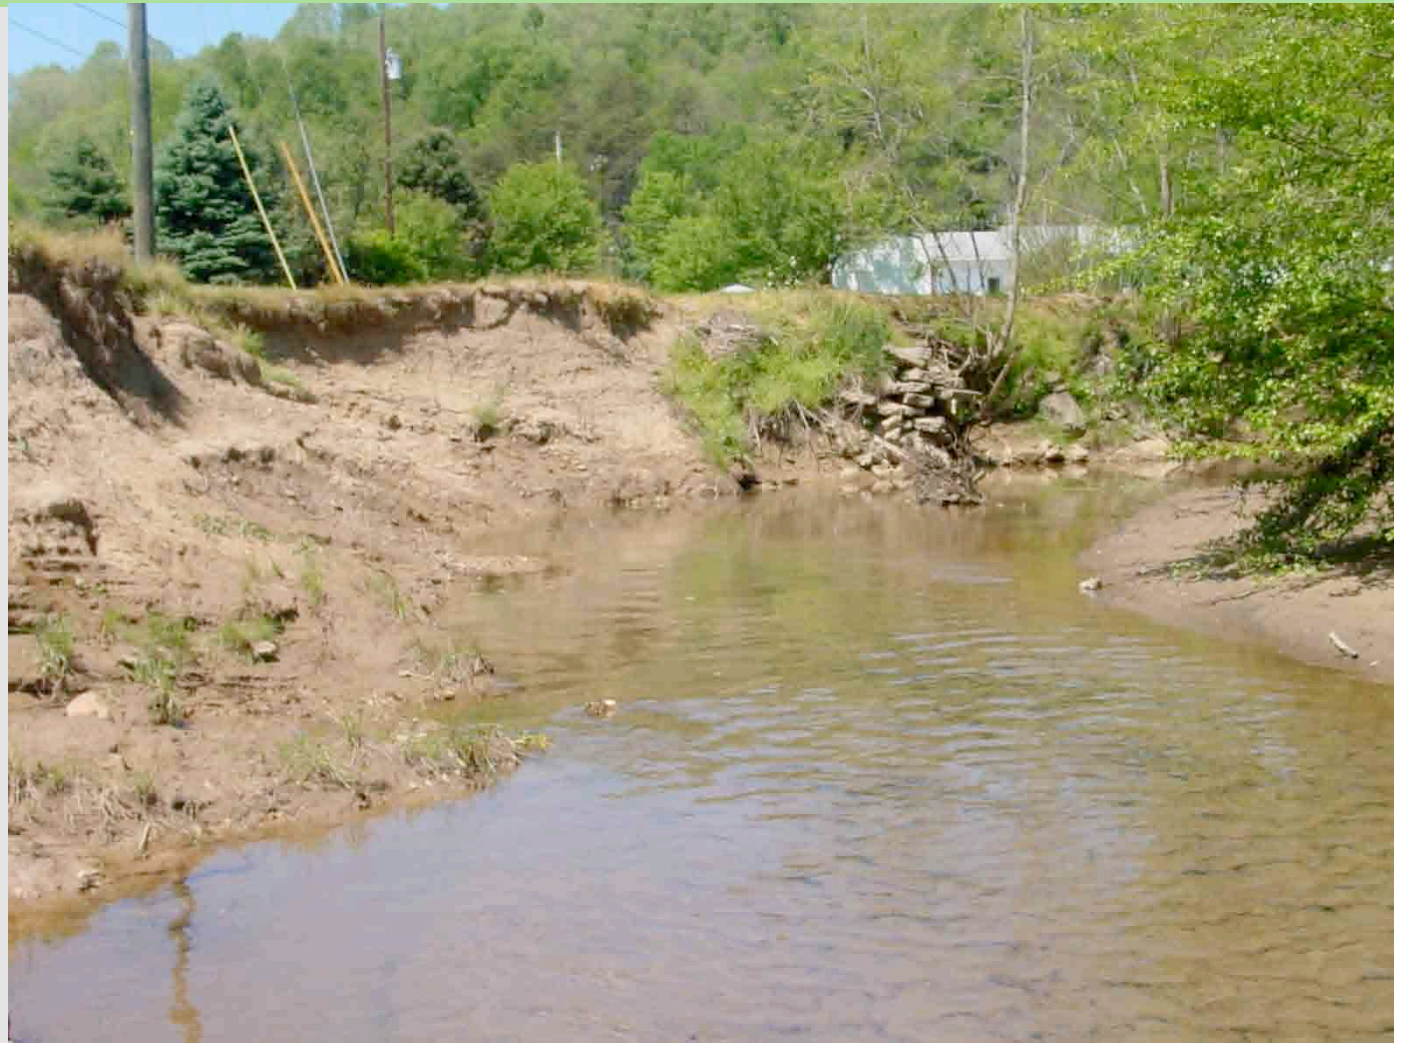
Sand

- deeply entrenched channels
- highly erodible banks
- poor habitat in channel for fish

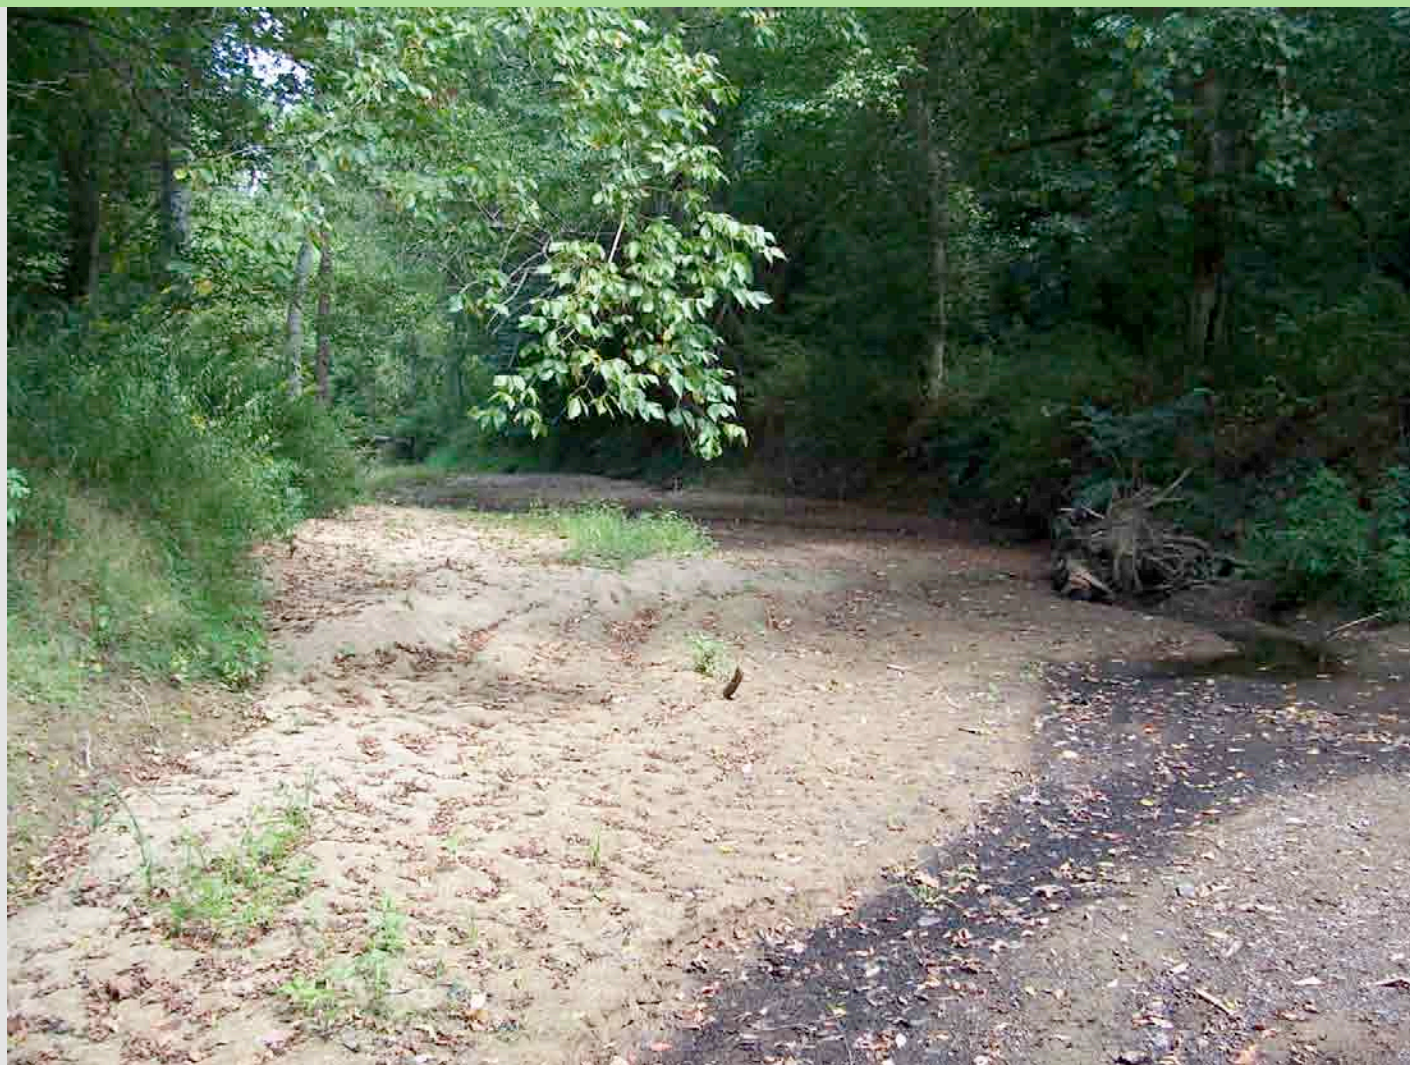
And More Sand

- deep sand deposits in channel
- during low flow, surface water drains through the sand deposits

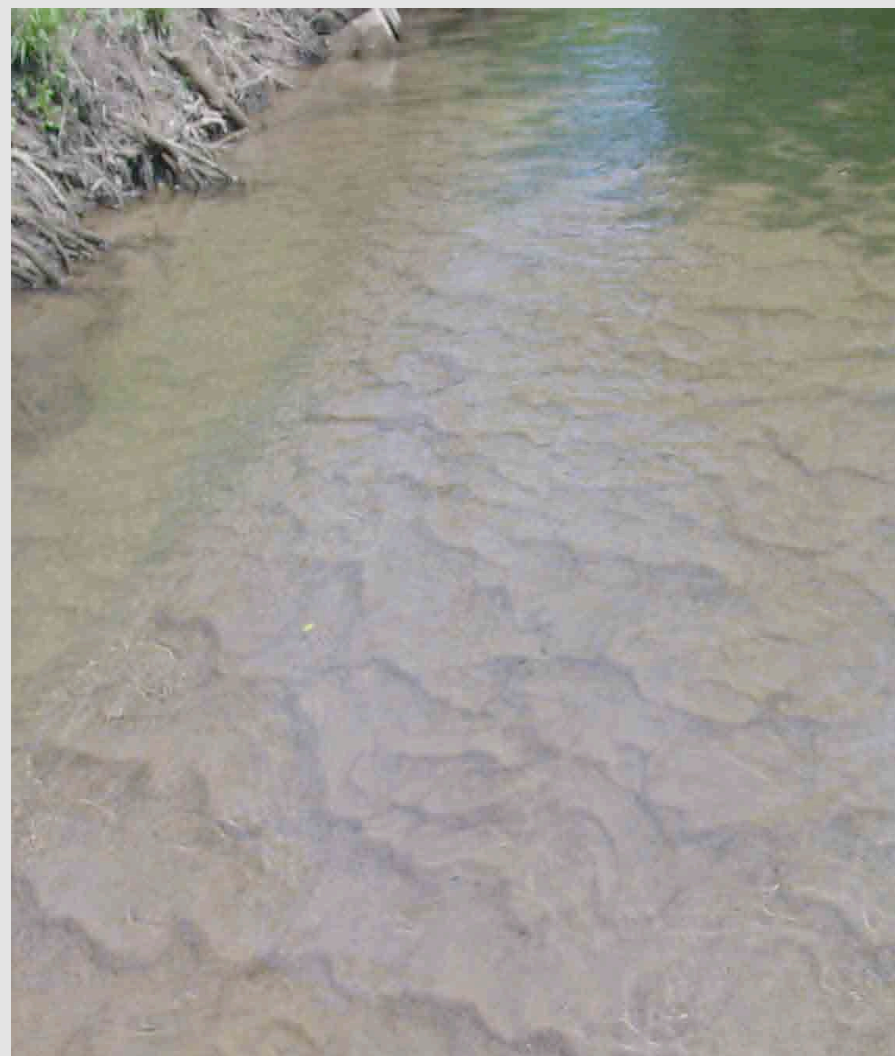
Bedload Transport Observations

- after high flow events, pools and riffles evident
 - floods scour sand out of channel
- during low flows, bedload transport still high as sand is redistributed
 - between storm events pools fill with sand

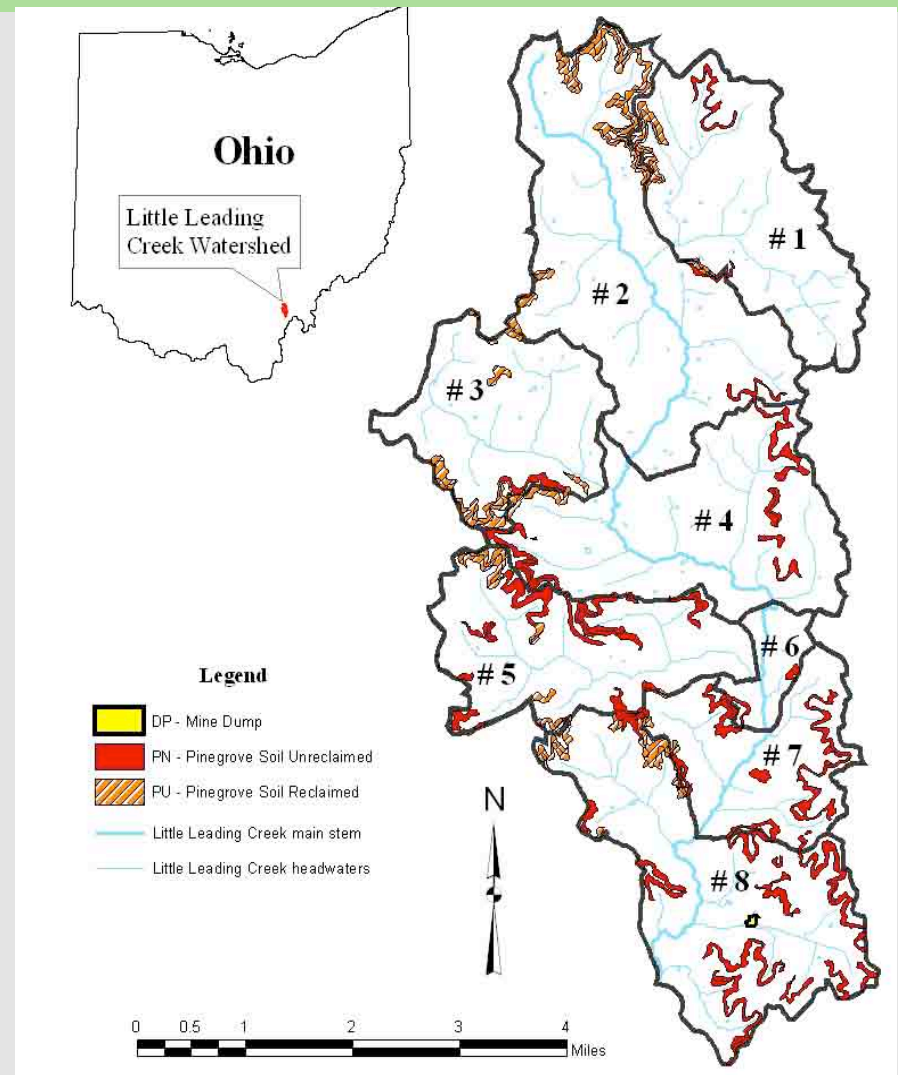
Assessment of AML Reclamation

- headwater and tributary creeks had well graded sediments including gravel and large stones
- often pavement apparent
- sites vegetated and no obvious erosion problems
- where is all this sand coming from?

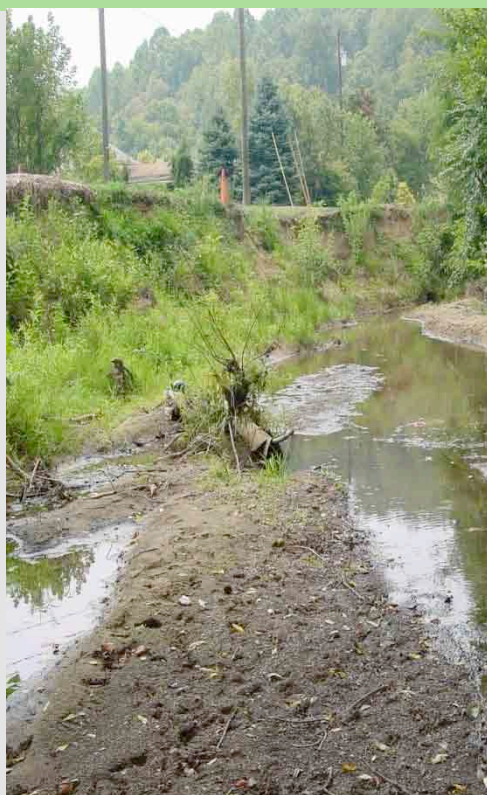
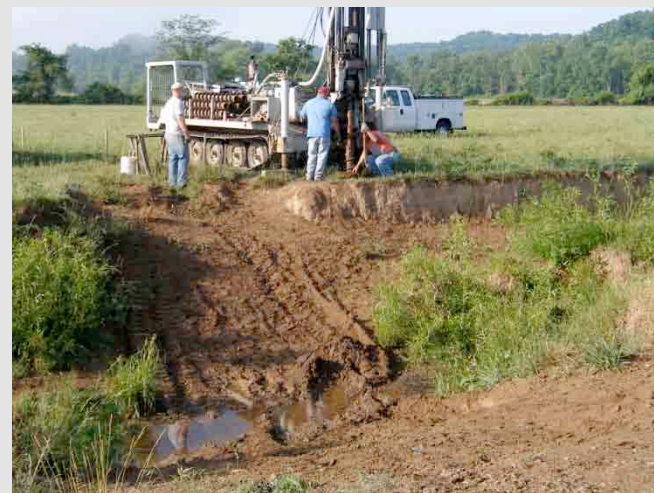
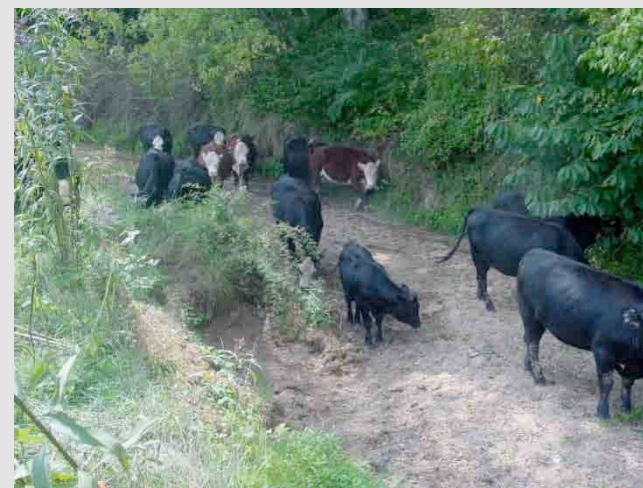
Bank Erosion Common on Mainstem

- deeply entrenched channel
- poorly vegetated and easily erodable banks
- in many locations cattle have access to creek
- bank erosion likely primary sediment source

- limit primary sediment source to the creek
- stabilize 2.75 miles of the most degradable stream banks
 - reconnect channel to floodplain
 - riparian revegetation
 - proper channel design
- coexist with cattle
 - exclusion from channel
 - drill wells to provide alternate water source
 - established crossings

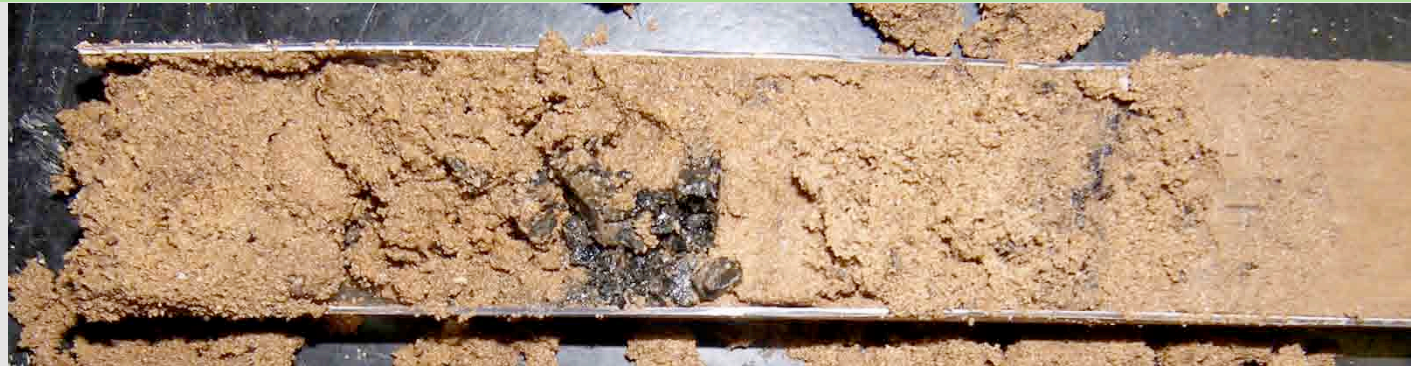
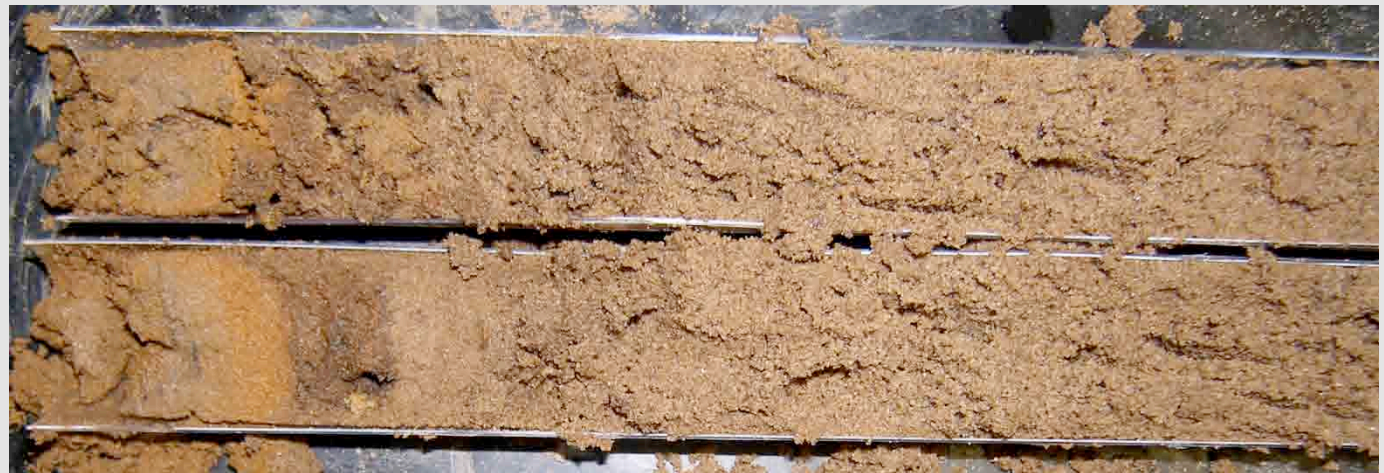
Typical Cores

- mostly poorly graded sand with between clay layers
- coal chips and fines spread through soil
- some layers with lots of coal
- significant orange staining often adjacent to heavy coal layer

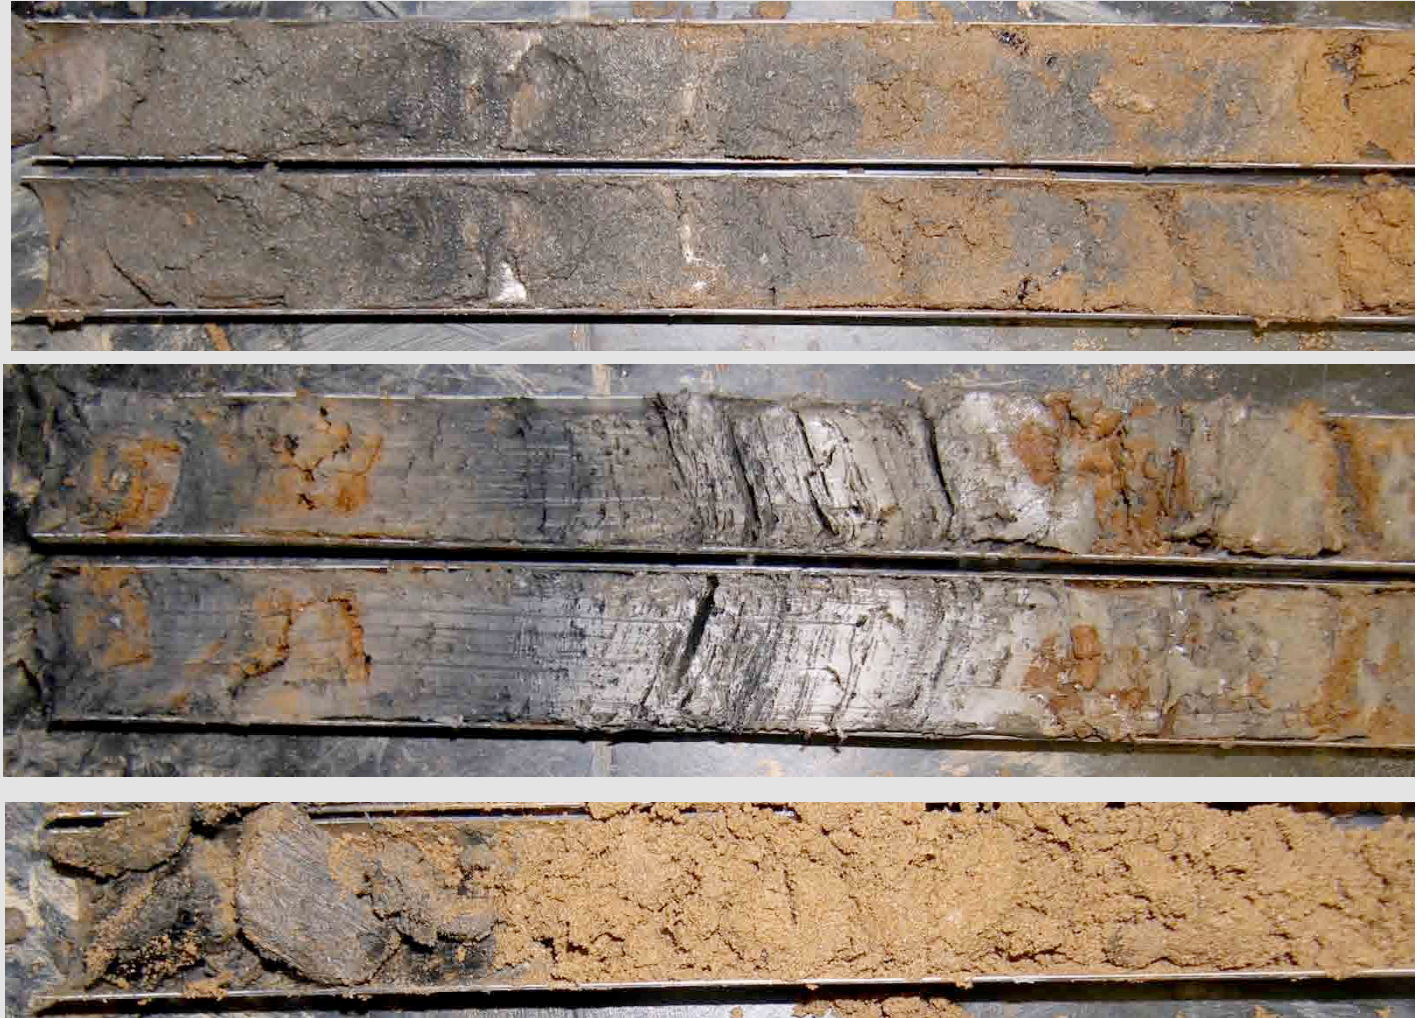
Deeper Cores

- at 6-10 feet most soils turned from tan or brown to grey or black
- occasionally at depth several inches of carbonized, recently deposited leaves, sticks, logs, and grass present

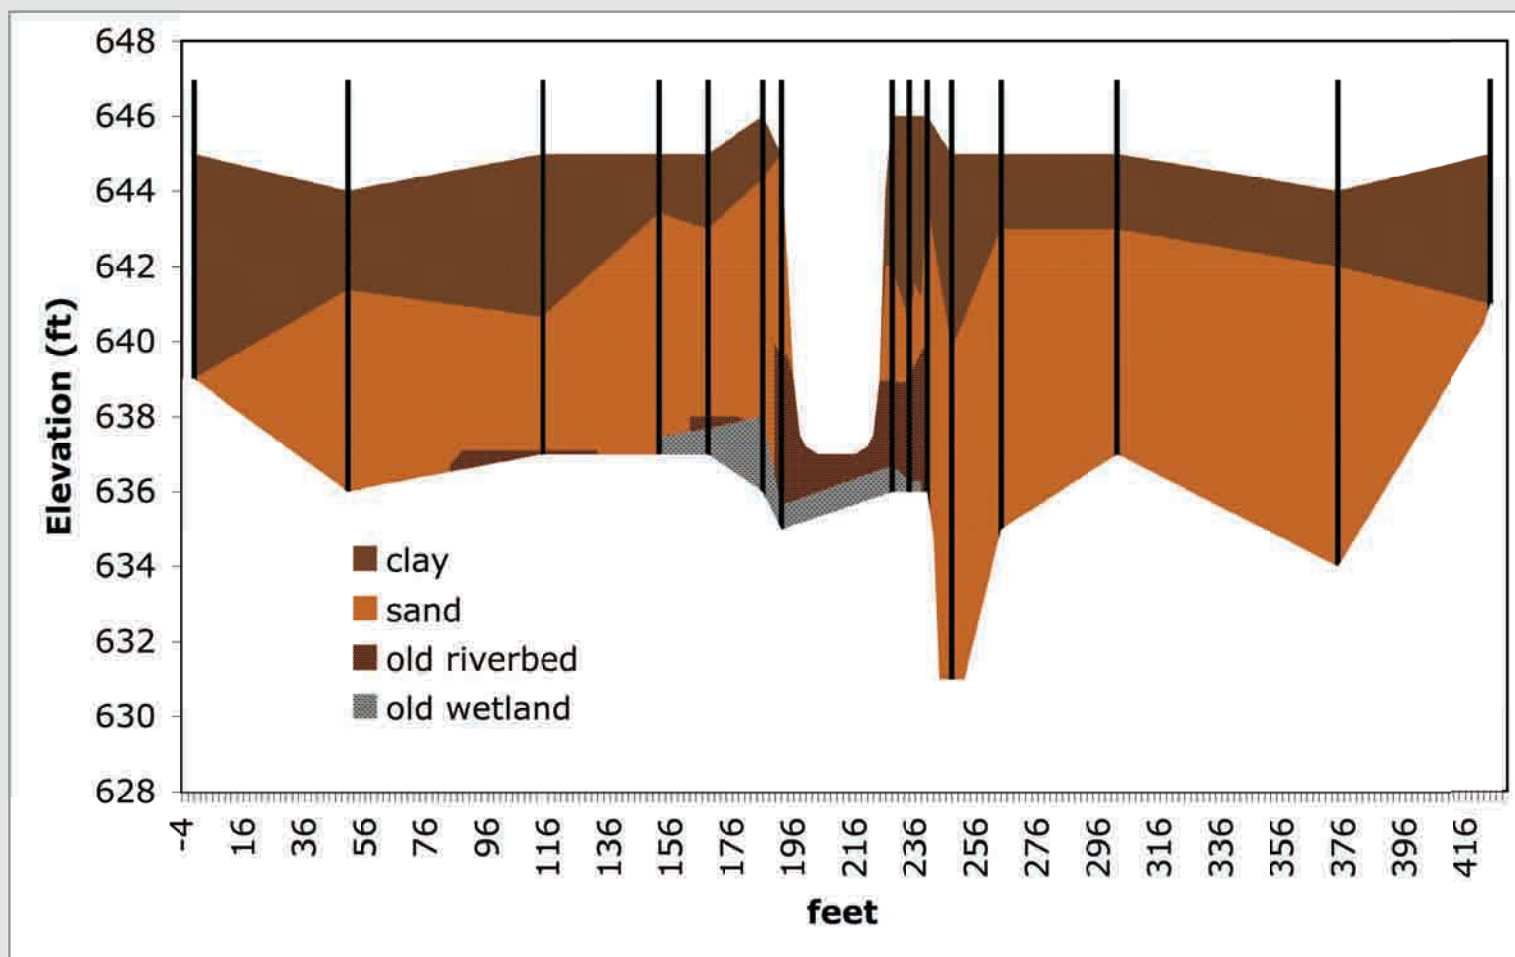
Harrisonville Stratigraphy

- sand and clay found up to 14 ft deep and over 200 ft from channel
- old river beds found over 100 feet from channel

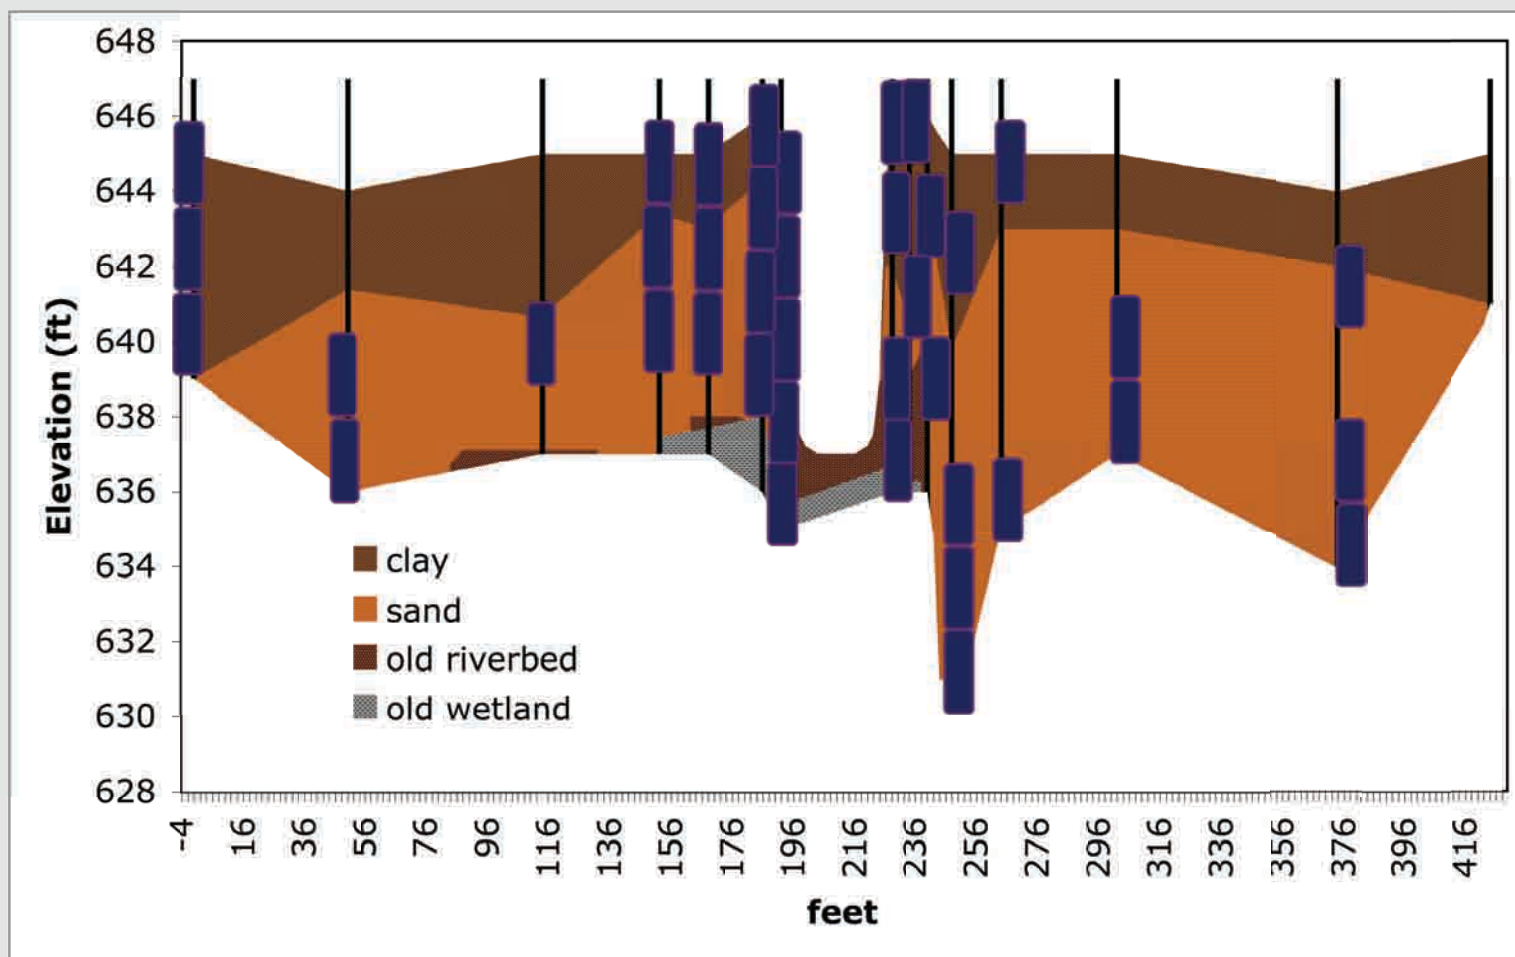
Coal in Harrisonville Cores

- coal chips and fines found throughout
- valley inundated with sediment from the strip mining over 14 feet deep

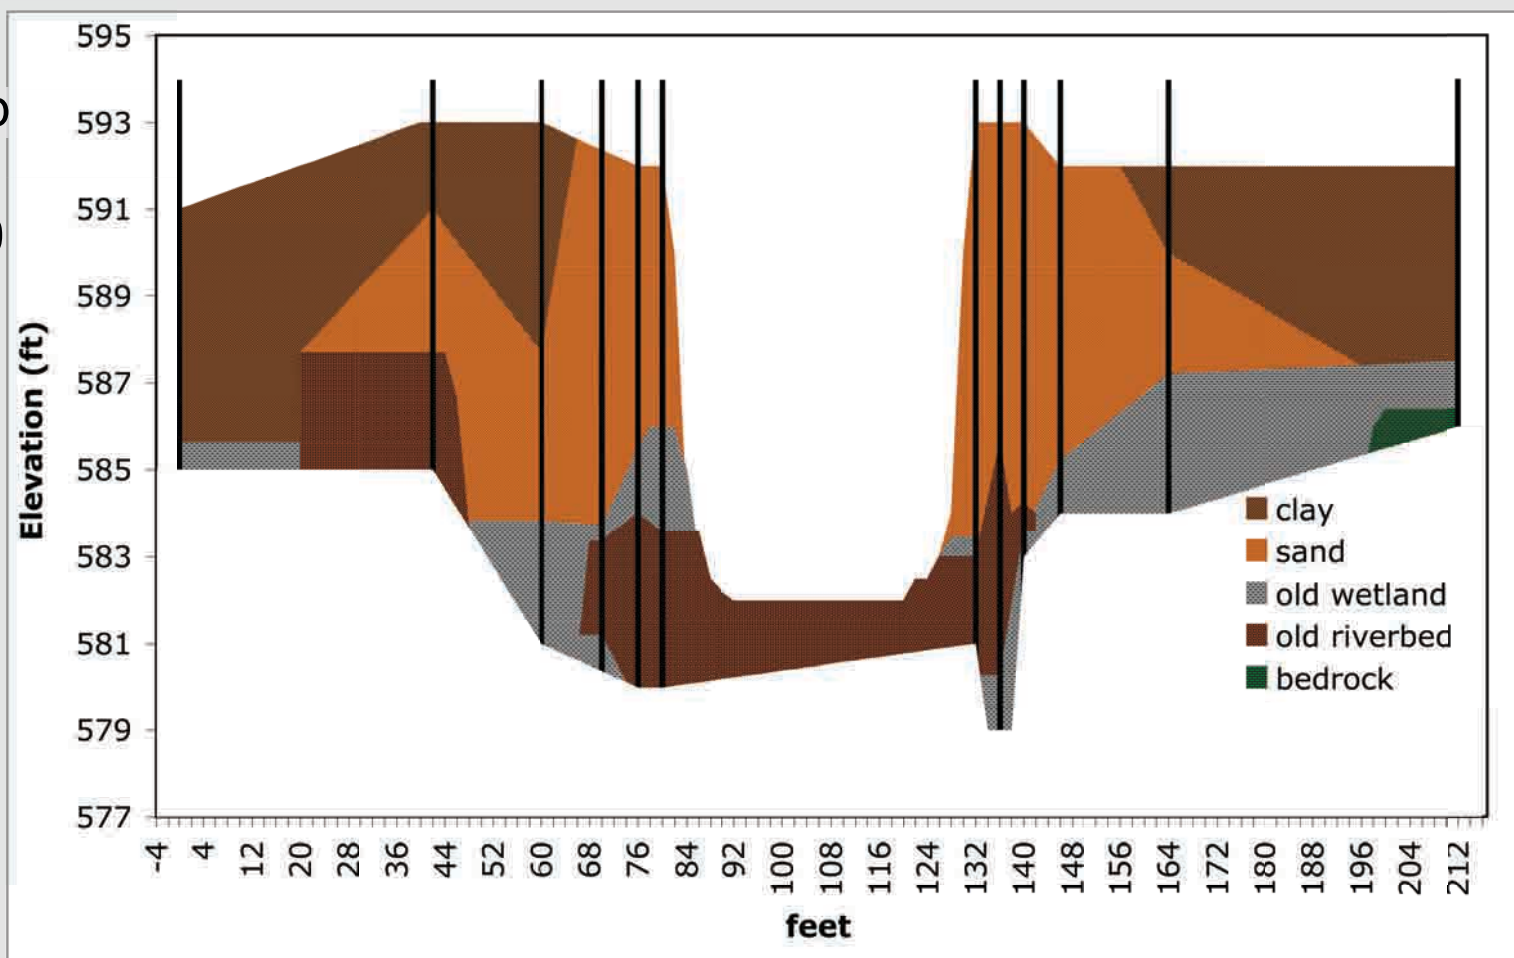
Peterson Stratigraphy

- sand and clay found up to 10 ft deep and over 100 ft from channel
- old river beds and thick layers of recently deposited organic matter found

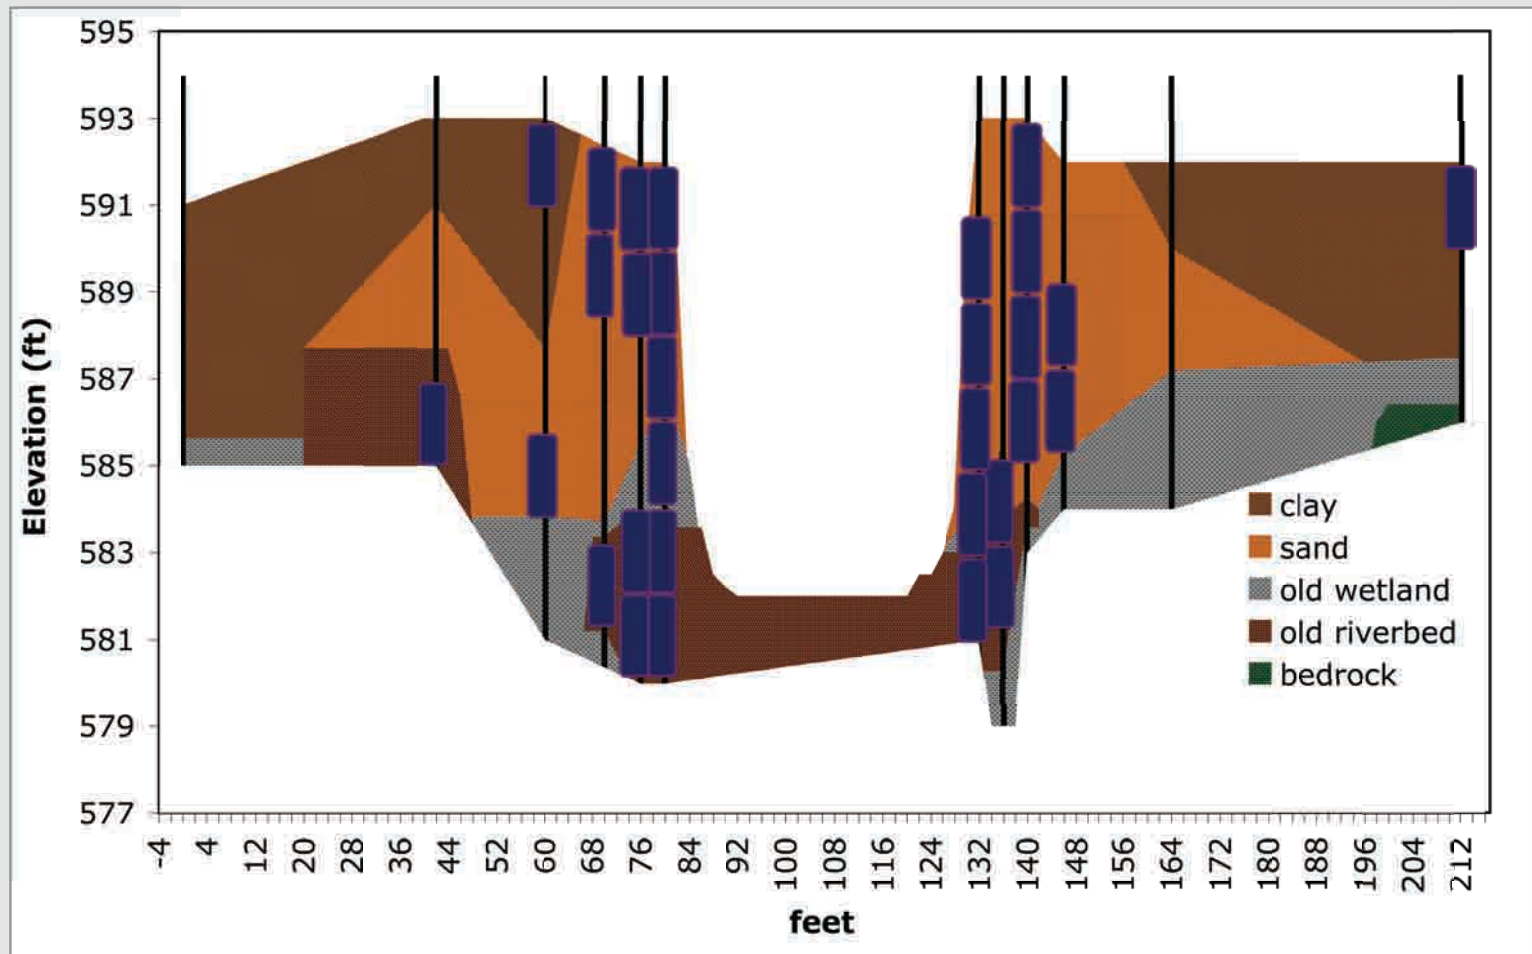
Coal in Peterson Cores

- coal found as deep as 12 feet
- no coal found in or below wetland sediments
- possibly original floodplain before inundated with sand
